## An investigation into the tripping behavior of longitudinally T-stiffened rectangular flat plates loaded statically and impulsively

# THESIS

MASTER OF SCIENCE IN MECHANICAL ENGINEERING

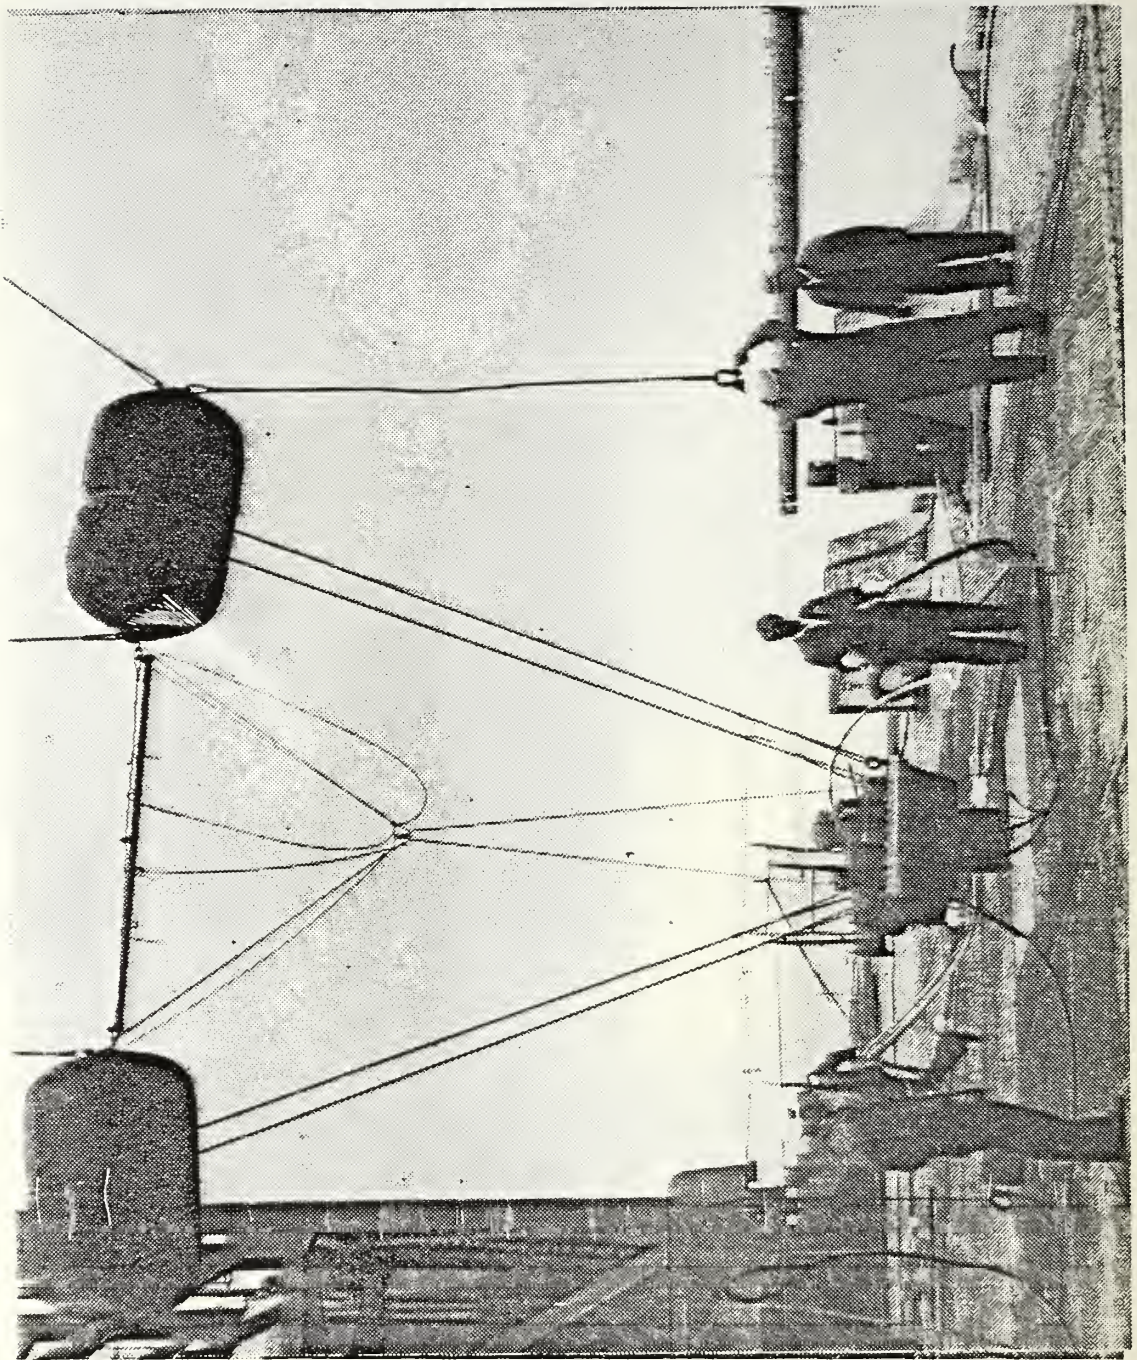
Figure 3.6    Test Panel and Chamber Slung from  
                  Pneumatic Fenders.

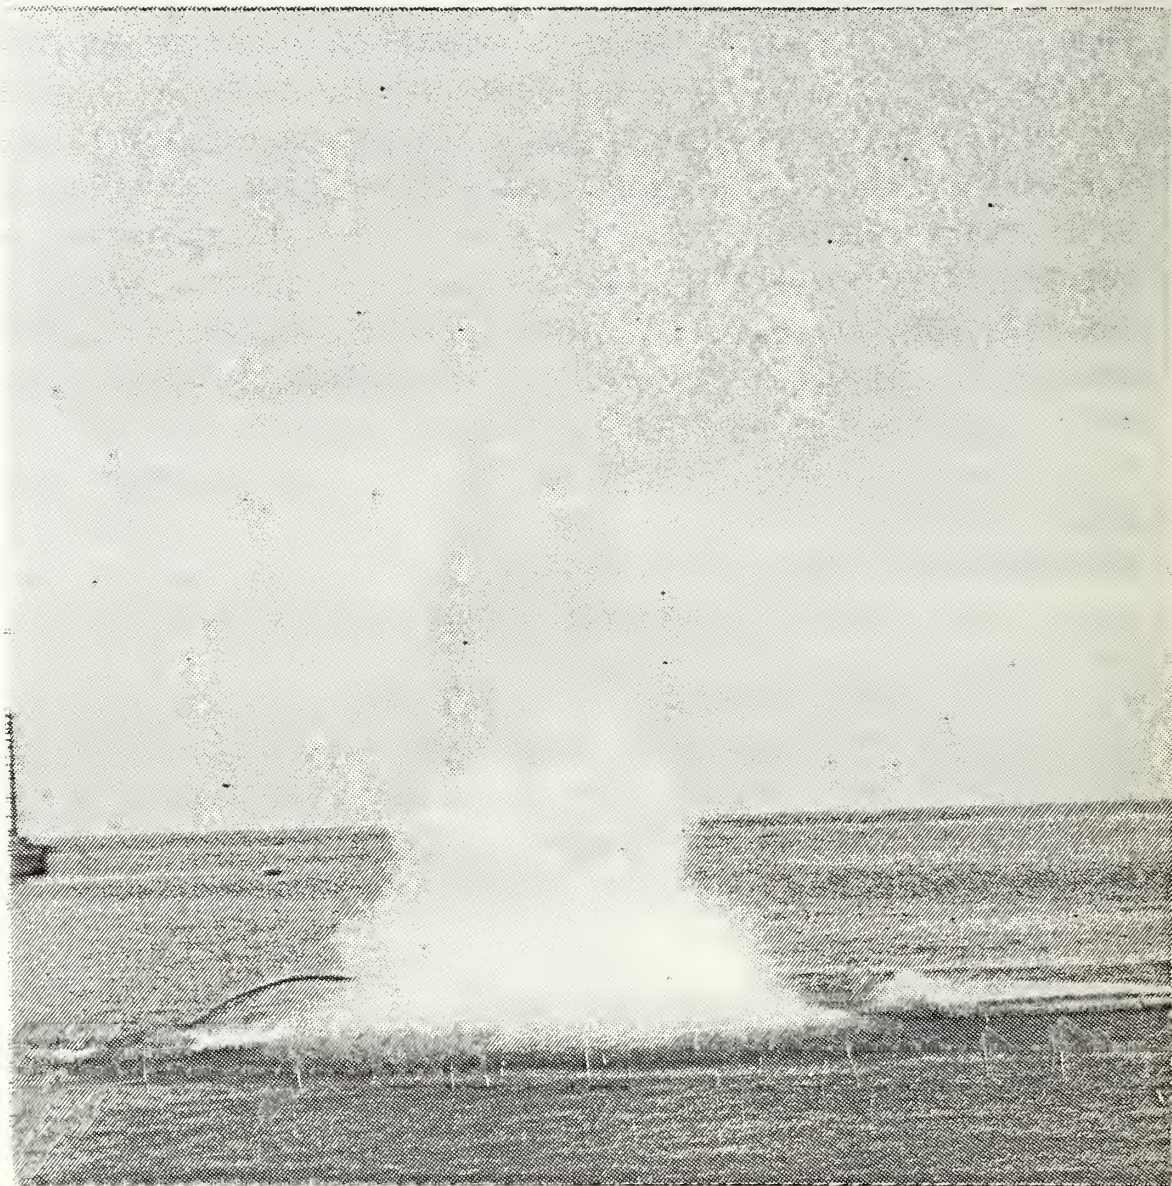
Figure 4.19    Eight-pound Charge Explosion Dome and  
Initial Venting.

The shot went off as planned and, as predicted, the 8 lb charge reacted as a 10 lb charge (determined by post-shot calculations). The dome and plume from the explosion were symmetrical, as was expected for the cylindrical charge used, see Figures 4.19 and 4.20. Also, as had happened during the Langan test [Ref. 16: p. 46], the pneumatic fenders were ruptured from the force of the explosion.
